## Wynland Water Instandhouding 2020/2021

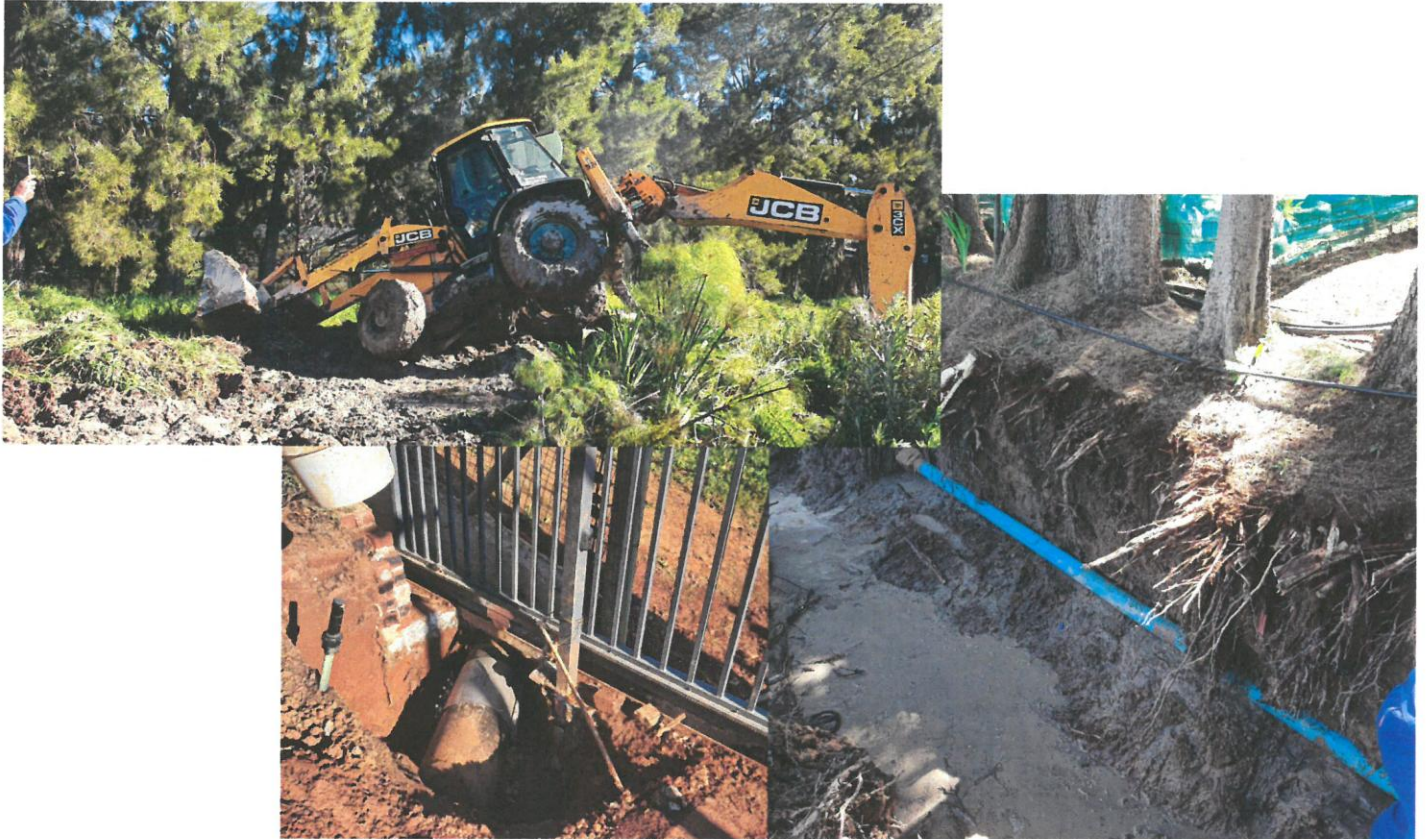
Daar was nie enige groot pypbreke nie maar heelwat kleiner breke en lekkasies het aandag geniet. Party meer uitdagend as ander...

A pipeline running through Stellenpark's parking lot has caused problems several times in the past and has recently burst twice again. We replaced a section of about 100m by inserting a high class of HDPE pipe inside the old asbestos and connecting it on both sides.

We are also in the process of replacing 300m of another line that regularly bursts with HDPE pipe. However, the very wet winter made it difficult to work there and the work will be completed once the area has dried out enough.

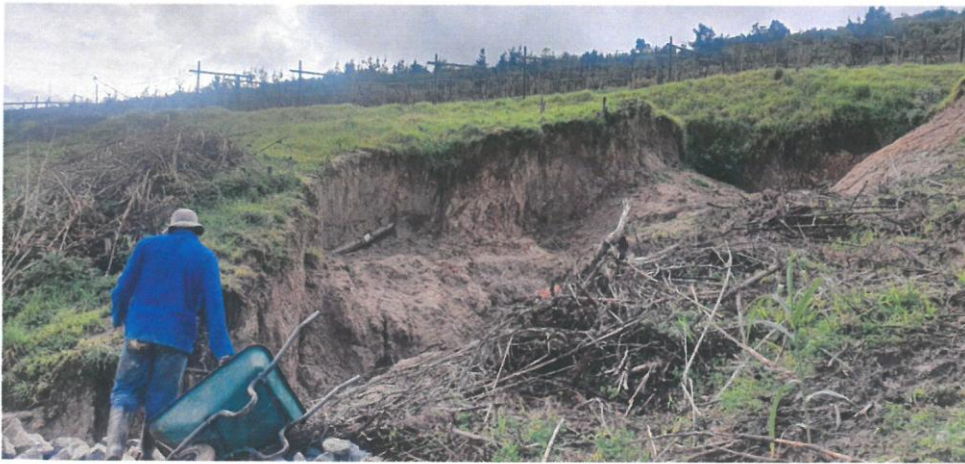
## Lombardi dam oorloop - H1

Die oorloop van 'n dam het die opvulling rondom die H1 hooflyn ondermyn en veroorsaak dat die pyp kraak.

Due to erosion and very heavy rains, part of the H1 pump line washed open. The 250mm pipeline was laid downstream of Lombardi's dam overflow. Gabions had to be urgently packed and material backfilled to stabilize the ground:

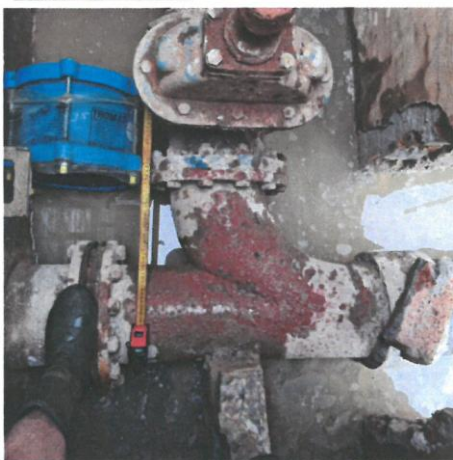
## Klepkamers

Daar is afsluitkrane en pypwerk in verskeie klepkaste vervang.

There are also shut-off valves and plumbing replaced in 2 valve cabinets (H8 and B3) (see photos).

The main pipeline serving the Vlaeberg area was shut down and emptied to replace a faulty shut-off valve.
